Site Code ¹ SW59

Location South of Simpson: Cooriemungle Road and Princetown Road

Sesquic, Semiaquic PODOSOL

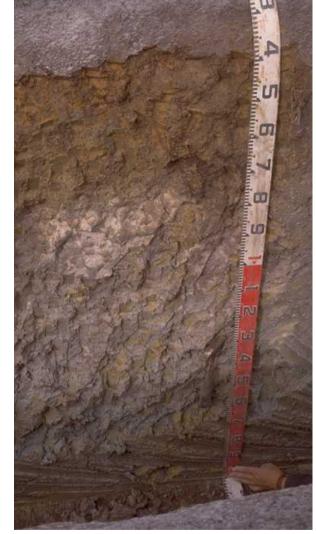
Waterlogged mottled clay subsoil at 1.5 m

Horizon	Depth (cm)	Description
A1	0–15	Black (2.5Y2.5/1); sandy loam; pH 5.6; smooth boundary to:
A2	15-30	Intermittent horizon; conspicuously bleached; clear and wavy boundary to:
B21s	15/30-60	Mottled yellowish brown (10YR5/8 moist) and very dark greyish brown (10YR3/2 moist); sandy clay loam; weak very fine polyhedral structure; weak to firm consistence (weakly cemented, weak 'coffee rock'); pH 5.3; gradual and wavy boundary to:
B22g	60–90	Light olive brown (2.5Y5/4 moist) with prominent yellowish brown (10YR7/8 moist) to yellow (10YR5/8 moist) mottles; sandy clay; very coarse (50–100 mm) polyhedral, parting to coarse (20–50 mm) blocky structure; sand coatings (whitish) on the larger ped faces; pH 5.5 clear smooth boundary to:
B23gss	90+	Light greenish grey (5GY7/1 moist); heavy clay; brownish yellow (10YR6/8 moist) mottles; very coarse (50–100 mm) polyhedral, parting to coarse (20–50 mm) blocky structure; slickensides (>50 mm) present; pH 6.3.

The lighter textured topsoil and landscape position renders the soil surface less prone to pugging damage than many of the soils in the district. The weakly cemented subsoil (B21s) is acid, has low levels of nutrients and poor nutrient holding capacity. Regular applications of balanced fertilizer as well as lime are needed to get good pasture production on these soils. The severe waterlogging and saturation of the deeper heavy clay subsoil is a permanent limitation to root growth as well as contributing to the landslide hazard associated with the slopes below this site. See also SW53 for soil in equivalent landscape position but without Hanson Plain Sand topsoil

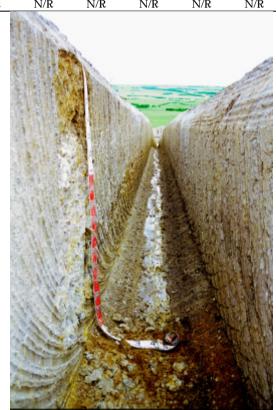
Landform Dissected plain

Element Upper slope / crest
