Site Code ¹ **SW87**

Epihypersodic-Endocalcareous, Self-Mulching, Black VERTOSOL

¹ Source: MacEwan R, Imhof M (in press) Major Soils and Landscapes along the Southwest Gas Pipeline 1999. DPI

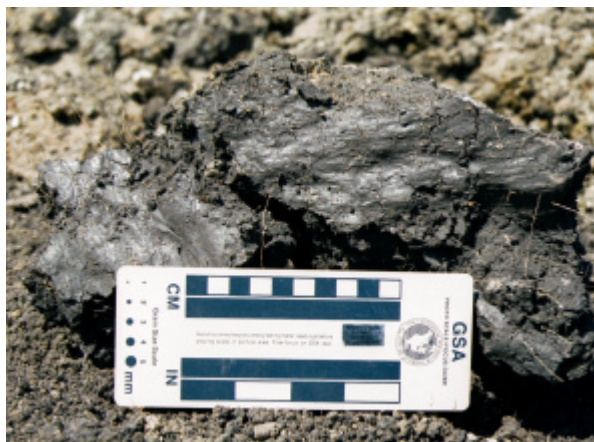
Lenticular ped from B21 horizon

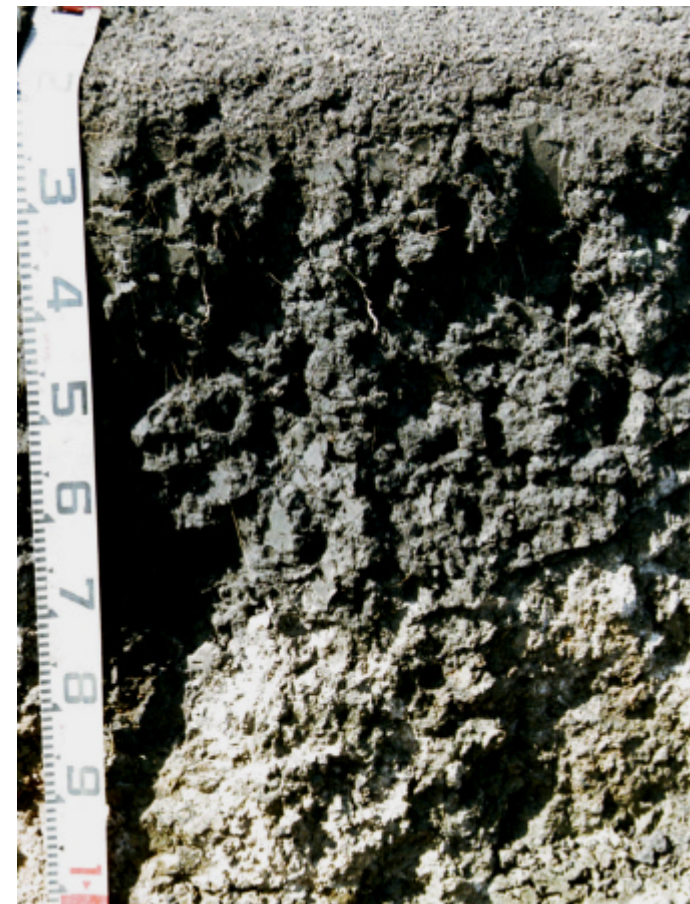
Horizon	Depth (cm)	Description
A1	0-15	Very dark grey (10YR3/1 moist and 10YR4/1 dry); light medium clay; thin self-mulching surface; smooth-faced coarse blocky structure below surface; strong consistence, deep cracks to surface; pH 5.7; gradual boundary to:
B21ss	15-50/70	Black (2.5Y2.5/1 moist, dry); heavy clay; strong, coarse (>100 mm) irregular lenticular structure, parting with difficulty to medium (>20 mm) lenticular peds, prominent slickensides increasing in size with depth; pH 8.0; clear and wavy boundary to:
B22k	50/70 +	White soft calcium carbonate (CaCO ₃) with fine olive brown (2.5Y4/3 moist) and dark yellowish brown (10YR4/6 moist) mottles in clay matrix; medium clay to light medium clay; pH 8.3

The very high wilting point (i.e. 28%) indicates that plants will be unable to fully utilise light rains, when the soil is dry. In moist to wet conditions, excessive tillage, trafficking or over stocking could result in structural damage (i.e. compaction, smearing). The subsoil has high shrink-swell properties, is dense, coarsely structured, strongly sodic and disperse strongly in water. These properties will restrict root growth and drainage when wet. When the soil is dry, heavy rains will run into soil cracks. There are engineering implications (e.g. disturbance to building foundations).

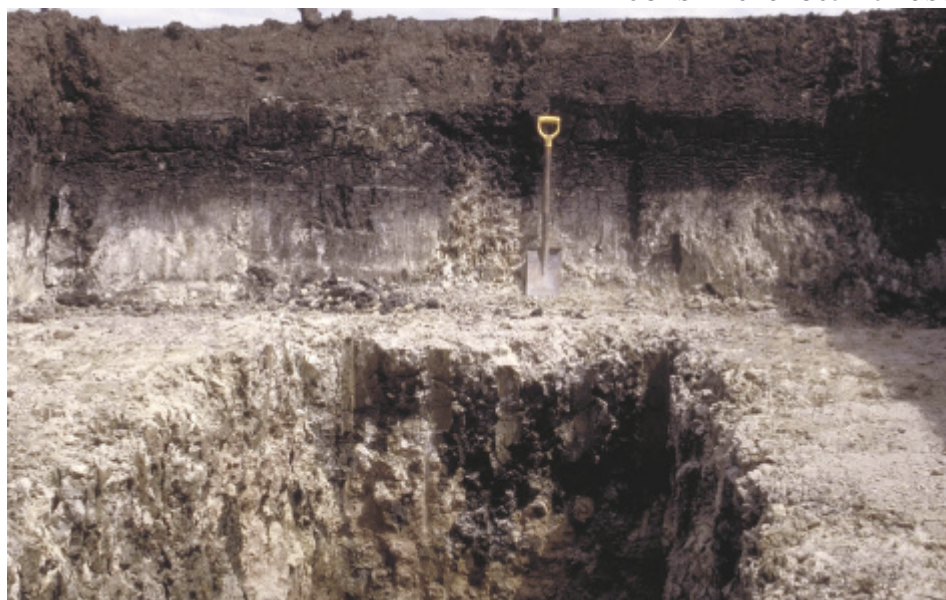
Excavation at the Cressy-Shelford road crossing shows highly calcareous subsoil to depth

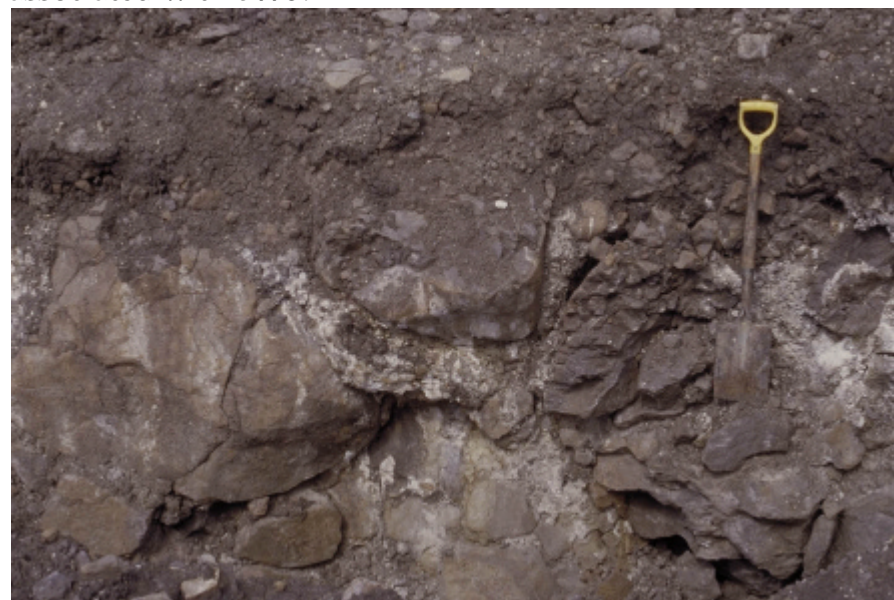
Excavation to the west of SW87 (very gentle rises) shows shallow soil over fractured rock
