Site Code¹ CLRA 7

Location Curlewis Golf Club (Geelong Portarlington Road), Drysdale district, Bellarine Peninsula

Melacic, Sesquic, Aeric Podosol

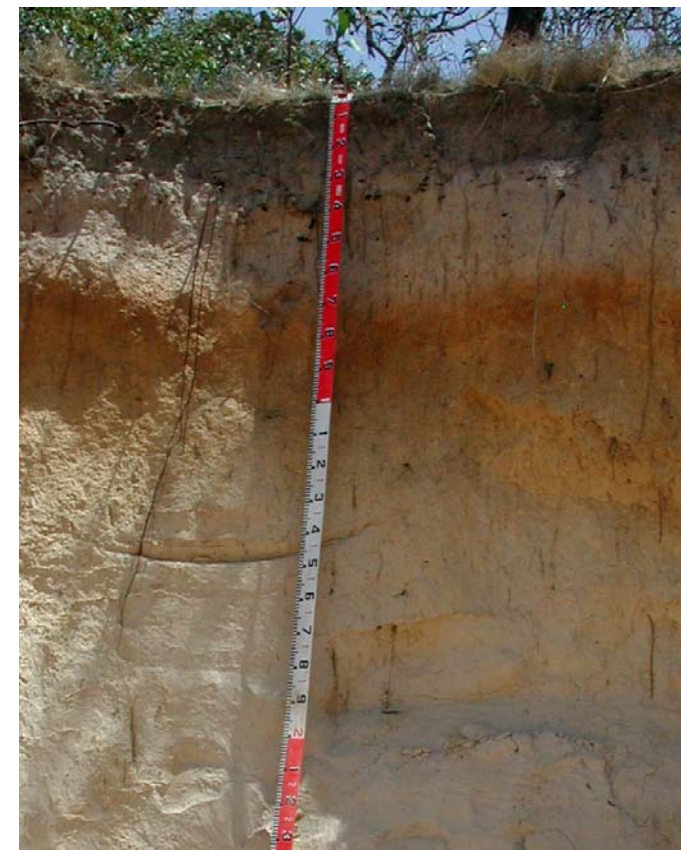
Cutting in side of dune at Curlewis Golf Club

Horizon	Depth (cm)	Description
A11	0–10	Very dark grey (10YR3/1); loamy sand; weak medium subangular blocky structure; rough ped fabric; very weak consistence; pH 4.5; smooth clear boundary to:
A12	10–20	Very dark grey (10YR3/1); light loamy sand; apedal single grain structure; sandy fabric; very weak consistence; pH 4.5; smooth gradual boundary to:
A2	20–50	Light yellowish brown (10YR6/3), conspicuous bleach (10YR7/2); sand; apedal single grain structure; sandy fabric; very weak consistence; pH 5.0; wavy clear boundary to:
Bhs	50–90	Brown (7.5YR4/3); heavy sand; apedal massive structure; sandy fabric; very weak consistence; pH 6.0; wavy diffuse boundary to:
C1	90–140	Yellowish brown (10YR5/4); sand; apedal single grain structure; sandy fabric; very weak consistence; few argillaceous laminae; pH 6.0; wavy diffuse boundary to:
C2	140–195	Very pale brown (10YR7/4); sand; apedal massive structure; sandy fabric; weak consistence; few argillaceous laminae; pH 7.0; wavy diffuse boundary to:

C3	195–210+	Brownish yellow (10YR6/8); sand; apedal massive structure; sandy fabric; strong consistence; pH 6.5.

This soil has a strong consistence contrast between the loose/weakly coherent deep sandy soil and the coherent subsoil which is sodic. It is important to maintain or improve the upper soil by increasing organic matter (particularly in the subsurface soil). The organic carbon content of the upper surface (A11) is 5.5% and the surface (A12) is 2.9%. This surface organic layer is important for soil stability as is the maintenance of a vegetative cover is important particularly where the surface soil is light and susceptible to water and wind erosion and variable slope (dunefield in this case).

Root penetration of the “coffee rock” at depth may be difficult with the hardsetting nature of the layer, but the sandy soil above provides a suitable physical medium for growth though with little water and nutrient holding capacity.
