Site code¹ SW100

Calcic, Hypernatric, Brown SODOSOL

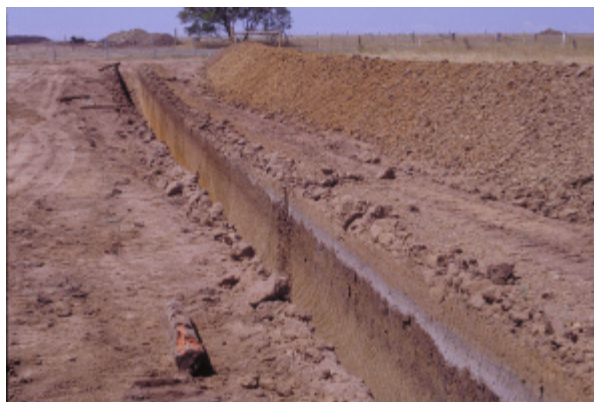
Trenched section at SW100 showing disappearance of A2 away from drainage line

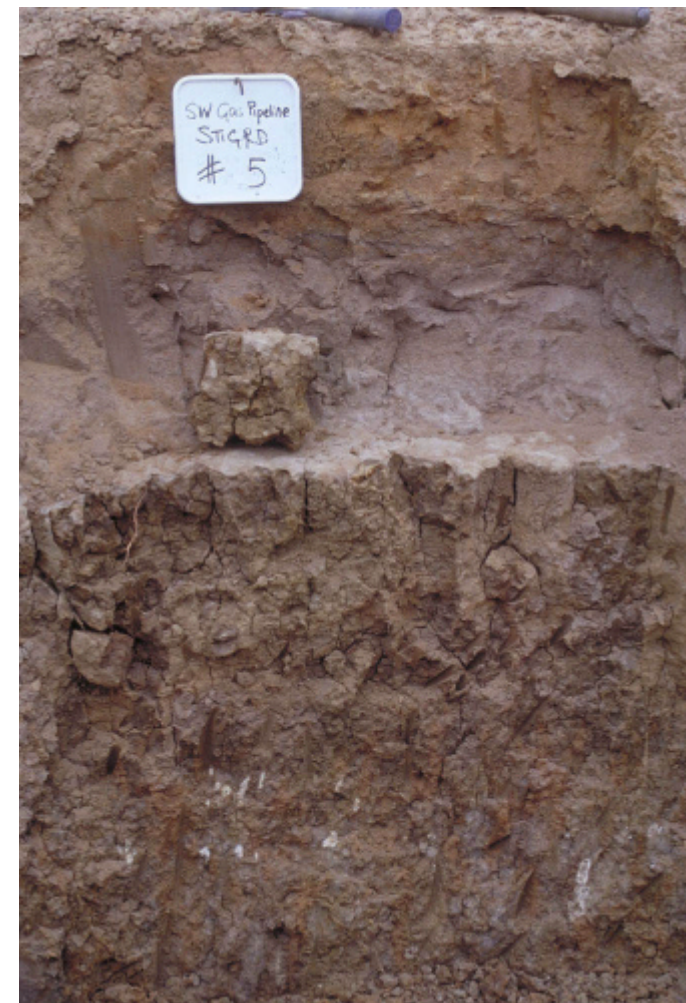
Horizon	Depth (cm)	Description
Ap	0-25	Reddish yellow mottled; <i>sand</i> ; hard setting (recently deposited material); abrupt boundary to:
A1b	25-30	Grey; loamy sand, buried A horizon clear boundary to:
A2	30-55	Greyish brown (10YR5/2 moist) conspicuously bleached (10YR7/1 dry) sand; massive structure; pH 6.4; sharp boundary to:
B21t	55-90	Brown (10YR4/3 moist) medium clay; very coarse (>150 mm) prismatic structure parting to coarse polyhedral peds; pH 8.2; gradual boundary to:
B22t(k)	90 +	Mottled brown and grey; clay loam; few (<5%) small calcium carbonate (CaCO ₃) accumulations at approximately 1.2 metres depth and concentrated around macropores; pH 9.5.

'Spewy' topsoil and sharp boundary to coarsely structured sodic clay subsoil render this soil very prone to waterlogging. The soil is situated at the upper end (initiation) of a drainage line carrying excess water from the basalt plain to the Moorabool River. This is highly erodible soil which should have permanent vegetation cover to protect river water quality. See also site SW99 for an associated soil type —these two sites are only 45 metres apart.

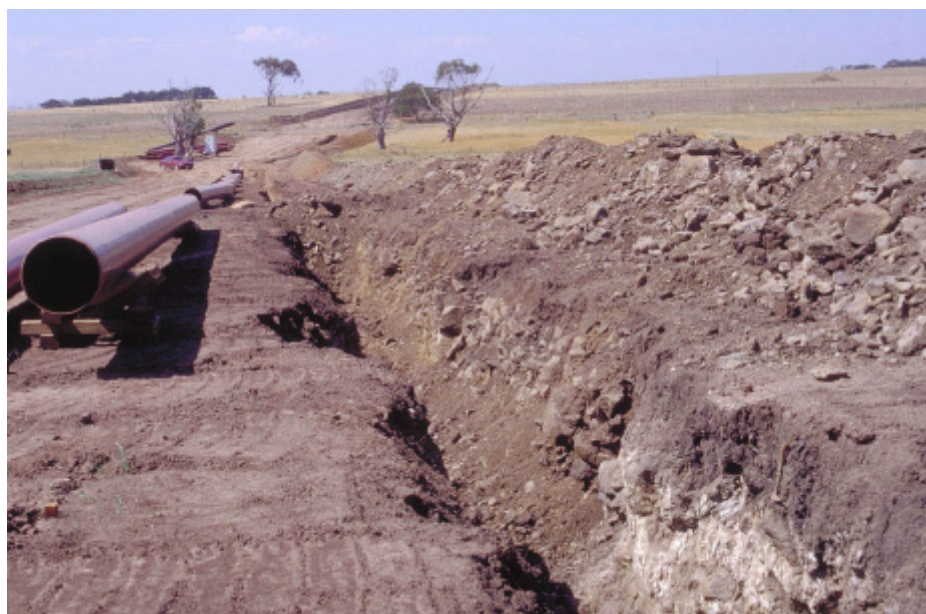
General view towards site SW100, basalt profiles in foreground trench. Note the change in colour of trench spoil across the drainage depression indicating the different provenance of soil parent material.

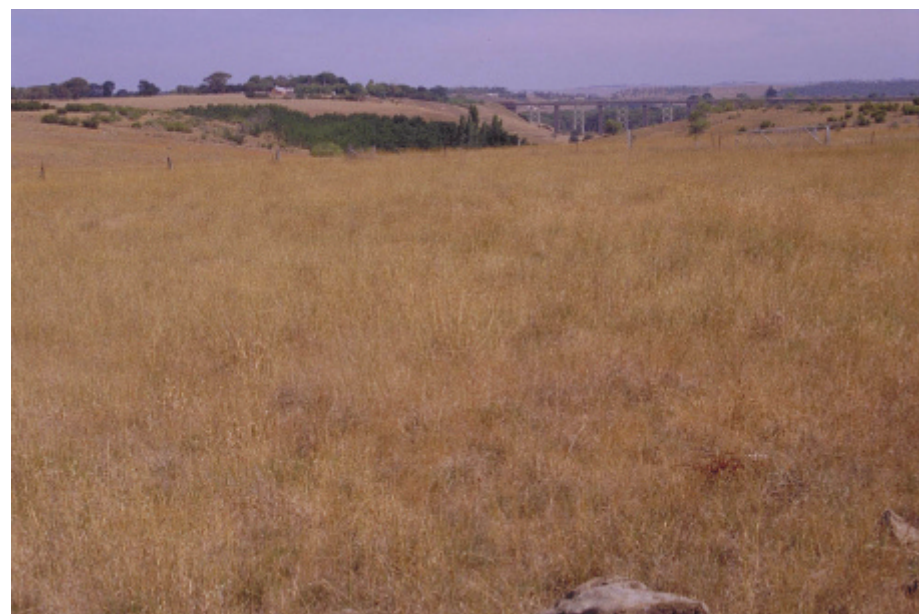
Dissection of the plain by Moorabool River to the south-west. The bridge in the distance is the Moorabool Viaduct which lends its name to the geological formation underlying the basalt plain in the eastern portion of the Corangamite region.
