Site code¹ SW101

'Slickensides' – prominent shrink-swell features dominate the subsoil

Location Lovely Banks, Bacchus Marsh-Geelong Road

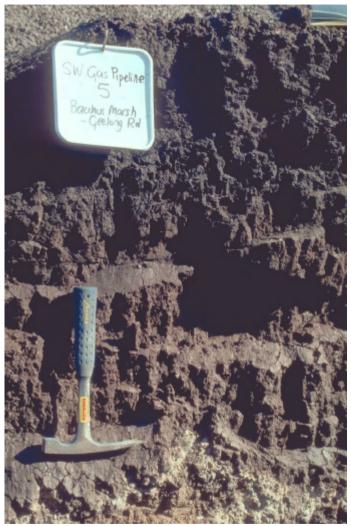
$\label{eq:continuity} Episodic-Endocal careous, Self-mulching, Black\\ VERTOSOL$

Horizon	Depth (cm)	Description									
A1	0-10	Very dark grey (5YR3/1 moist); light medium clay; self-mulching surface, rough faced peds (<10 mm); pH 6.9; clear and smooth boundary to:									
B21t	10-30/40	Very dark grey (5YR3/1 moist); medium heavy clay; strongly pedal, polyhedral structure with prominent small slickensides; pH 8.5; clear and wavy boundary to:									
B22ss	30/40-65/75	Dark reddish brown (5YR3/2 moist); medium clay; prismatic, polyhedral and lenticular structure, frequent large (>300 mm) slickensides; pH 9.2; wavy and abrupt to clear boundary to:									
B23kss	65/75+	Dark greyish brown (2.5Y4/2 moist) or grey (2.5Y5/1); light clay; with very large slickensides (up to 1 metre) and abundant large patches of whitish soft carbonate.

Deep fertile soil with strongly structured surface. Shrinking and cracking constitutes a major hazard for engineering works (buildings, roads, power poles). Sodicity of the soil is high and this, coupled with the high clay content, will limit water movement through the profile.

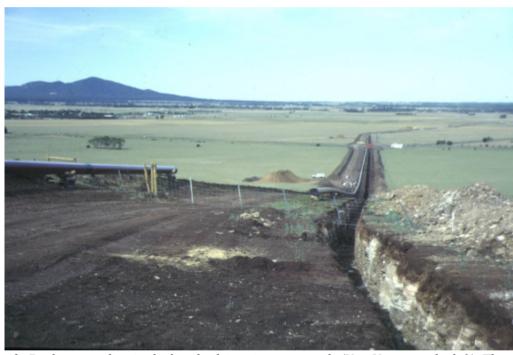
Lovely Banks monocline in the basalt plain, view eastwards (You Yangs on the left). The road running across the image is the Bacchus Marsh-Geelong road. SW101 is situated in the pipeline trench near the road crossing

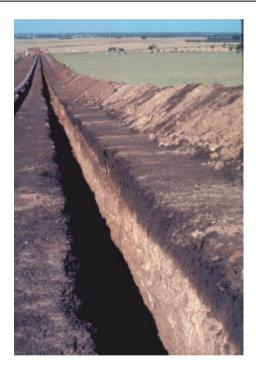
Trench section on the Lovely Banks Monocline slope showing shallower self mulching soil overlying highly calcareous subsoil
