Site code¹ SW27

Melanic-Vertic (& Ferric), Subnatric, Grey Sodosol

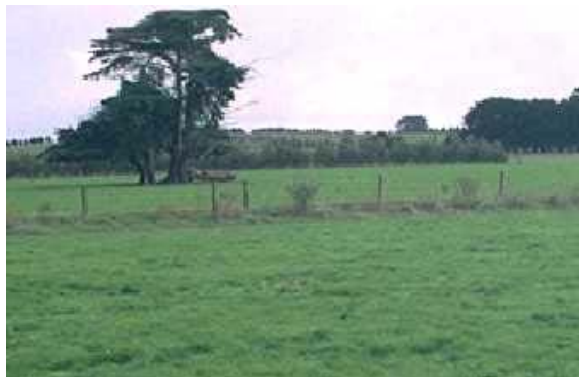
Pasture used for grazing

Location Bostock Creek
Landform Lower slope in gently undulating hills
Geology Quaternary – Newer volcanics (scoria)
Element Lower slope

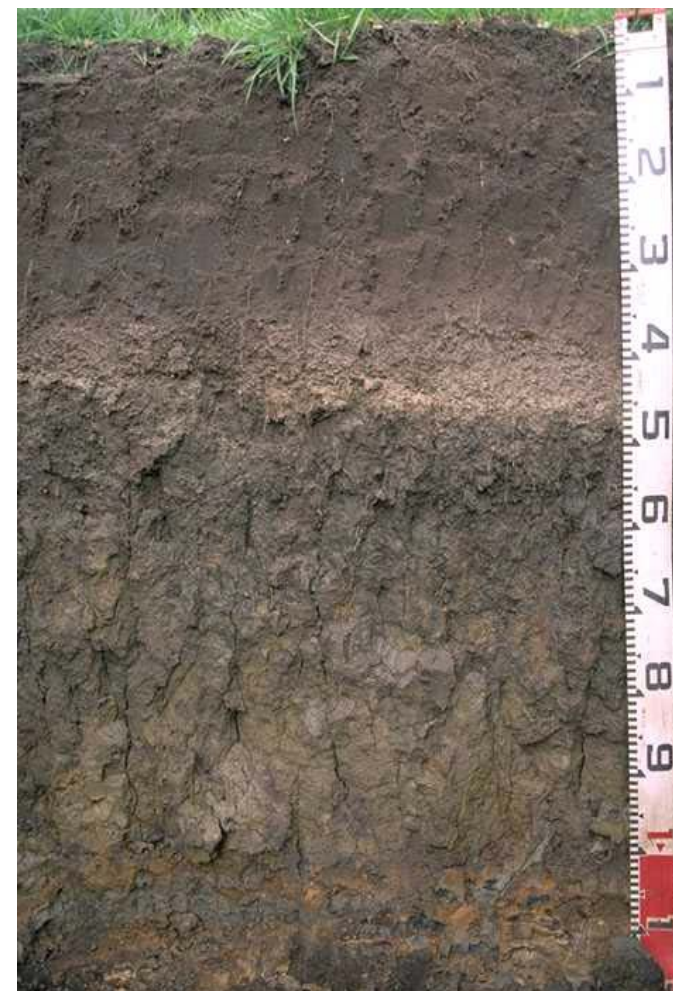
Horizon	Depth (cm)	Description
A11	0–15	Black (10YR2/1); fine sandy clay loam; weak to moderate medium polyhedral, parting to moderate fine polyhedral structure; firm to very firm consistency (dry); weak-firm consistence (moist); pH 6.1; gradual boundary to:
A12	15–40	Very dark grey (10YR3/1); fine sandy clay loam; moderate medium polyhedral, parting to moderate fine polyhedral structure; weak-firm consistence (moist); pH 5.8; abrupt boundary to:
A2	40–50	Brown (10YR5/3), conspicuously bleached (7.5YR7/2dry); fine sandy clay loam; apedal structure; very many (> 50%) medium size(2–6 mm) ferruginous nodules ;pH 6.5; sharp boundary to:
B21	50–70	Very dark greyish brown (becoming dark greyish brown (2.5Y4/2) with depth) with yellowish brown (10YR5/6) mottles; heavy clay; moderate very coarse prismatic, parting to moderate coarse to medium polyhedral structure; strong consistence (dry); pH 6.5; gradual boundary to:

B22	70–100	Greyish brown (2.5Y5/2), with yellowish brown (10YR5/8) mottles; heavy clay; strong very coarse prismatic, parting to coarse prismatic and very coarse blocky structure; strong consistence (dry); many slickensides present; pH 7.0; abrupt boundary to:
C	100+	Weathered volcanic ash.

The soil profile has deep surface (A1) horizons that are not hard, have a moderate organic matter contents and a reasonable aeration capacity. They will be well suited for plant growth.

The strong texture contrast between the surface soil and the coarser structured subsoil is a very important soil feature. This can have a major effect by reducing and/or redirecting the internal drainage and restricting root growth beyond the upper horizons.

Mottled subsoils are common and are also an indication of periodic waterlogging, particularly if the mottles are pale (low oxygen conditions). Improved drainage may be beneficial.
