Site code<sup>1</sup> SW48

Grazing paddock on undulating rises

**Location** Wangoom  
**Landform** Gently undulating rise  
**Geology** Quaternary-Newer volcanics (basalt)  
**Element** Lower slope

Bleached-Vertic (& Ferric), Eutrophic, Brown Chromosol

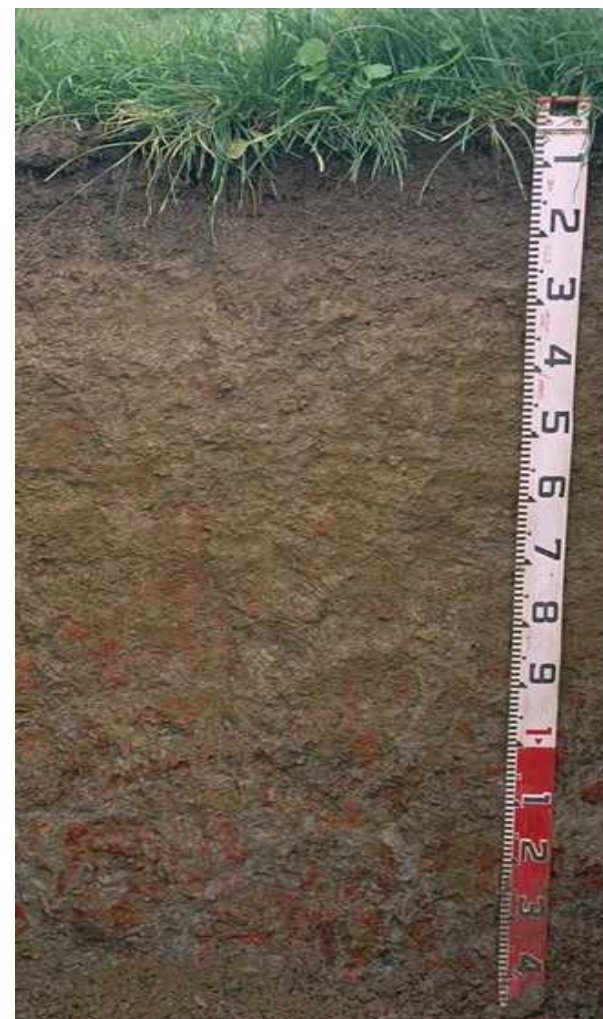
Horizon	Depth (cm)	Description
A1	0–5	Very dark brown (10YR2/2); fine sandy clay loam; contains many (40%) ferruginous nodules (2-5 mm in size); pH 5.7; clear change to:
A2	5–25	Brown (10YR5/3), conspicuously bleached; gravely sandy loam; contains very many (80%) ferruginous nodules (2–15 mm in size); pH 6.4; sharp change to:
B21	25–50	Dark yellowish brown (10YR4/4) with yellowish brown (10YR5/6) and some red (2.5YR5/8) mottles; medium clay; strong coarse polyhedral, parting to strong medium polyhedral and strong lenticular structure; weak to firm consistence (moist); pH 6.6; gradual change to:
B22	50–70	Yellowish brown (10YR5/4) with yellowish brown (10YR5/6) and red (2.5YR5/8) mottles common; medium clay; strong coarse polyhedral, parting to strong medium polyhedral and medium to fine lenticular structure; pH 6.3; gradual change to:
B23	70–105	Light brownish grey (10YR6/2) with many yellowish brown (10YR5/8) and red (2.5YR5/8) mottles; medium clay; strong coarse polyhedral, parting to strong medium polyhedral and medium to fine lenticular structure; pH 5.8; gradual change to:

B24	105+	Light grey (N6) with red (2.5YR5/8) and common strong brown (7.5YR5/6) mottles; light clay; strong coarse polyhedral, parting to strong fine polyhedral and medium to fine lenticular structure; weathered volcanic material present; pH 5.3.

The strong texture contrast between the surface soil and the coarser structured subsoil is a very important soil feature. This can have a major effect by reducing and/or redirecting the internal drainage and restricting root growth beyond the upper horizons.

Bleached A2 horizons (or subsurface soils) are a major feature of many of soils within the Corangamite region. These layers are usually an indication of restricted drainage, and they are poorly structured (often massive) and have low organic matter levels, nutrient and water holding capacities. They are often associated with a restrictive soil below - such as a denser clayey subsoil. These bleached horizons may act as conduit for subsurface flow, particularly on sloping ground.

Ferruginous and Ferromanganiferous nodules, and concretions ('buckshot') can restrict root penetration and limit available water holding capacity - forming a discontinuous or continuous pan where concentrated (>50%). Buckshot layers are also an indication of periodic waterlogging. Subsurface drainage may need to be considered where topsoils are shallow.

The subsoil is vertic, which indicates that significant shrinking and swelling occurs during wetting and drying cycles. This may disturb the roots of some plant species and has engineering implications (e.g. disturbance to fencelines and building foundations).
